TECHNICAL SERVICE BULLETIN

All Terrain Vehicle

Bulletin Number: ATV-09-01

SUBJECT: 2009 Sportsman XP 850 Crankcase Breather Valve Replacement

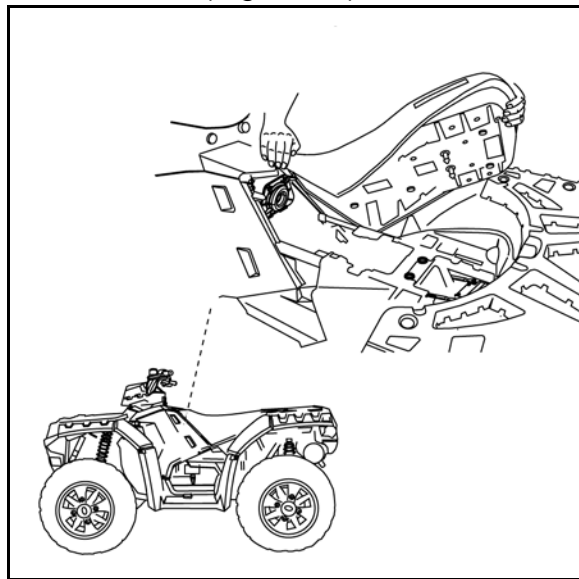
Figure #1

1. Turn the engine off and remove the seat (Figure #1)..

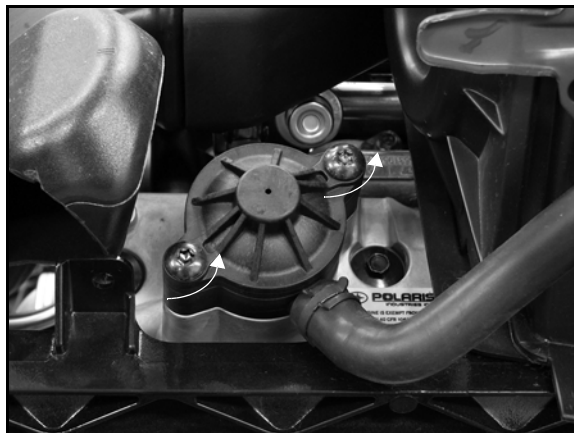
Figure #2

2. Remove the Crankcase Breather Valve using a #30 Torx bit (Figure #2).

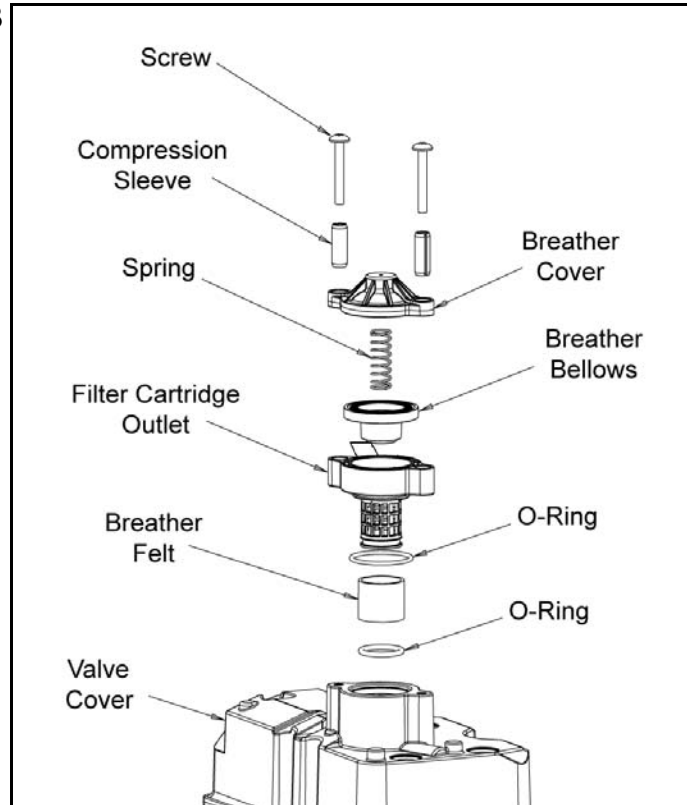
Figure #3

3. Install Crankcase Breather Valve Kit 2204191 according to the instructions provided with the kit (Figure #3). Duplicate copies of the kit instructions (PN 9922723) may be downloaded by accessing the 'Parts Detail Search' function on the Dealer Website..

4. Verify fasteners are torqued to **13 ft. lb. (18Nm)**.
5. Complete and place a Service Bulletin Decal in the specified location on the vehicle.
6. Reinstall the seat and verify it is secure.

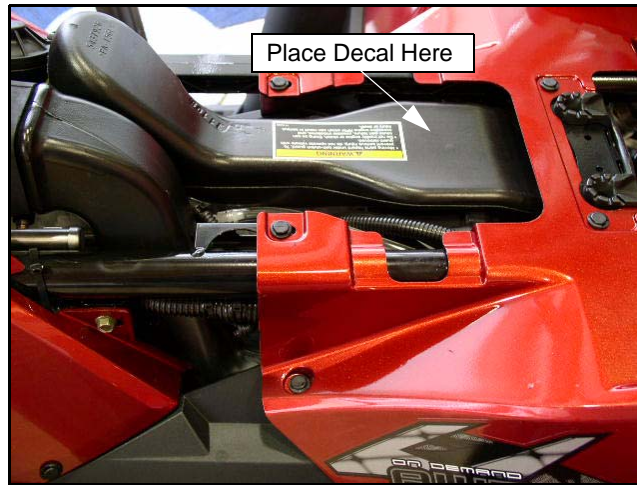
A Service Bulletin Completion Decal must be completed for this bulletin repair. Place the decal on the unit as shown. If you require more decals, order them through normal Polaris parts ordering channels.
